TECHNICAL ASSISTANCE TEAM FOR EMERGENCY RESPONSE REMOVAL AND PREVENTION
EPA CONTRACT 68-01-6669

January 19, 1987

TAT-05-F-01255

Re: Site Assessment of the TaraCorp Facility
McCook, Illinois
TDD# 5-8701-18 (FY 87)
TDD# 5-8612-49 (FY 87)
TDD# 5-8610-63 (FY 86)
TDD# 5-8608-01 (FY 86)

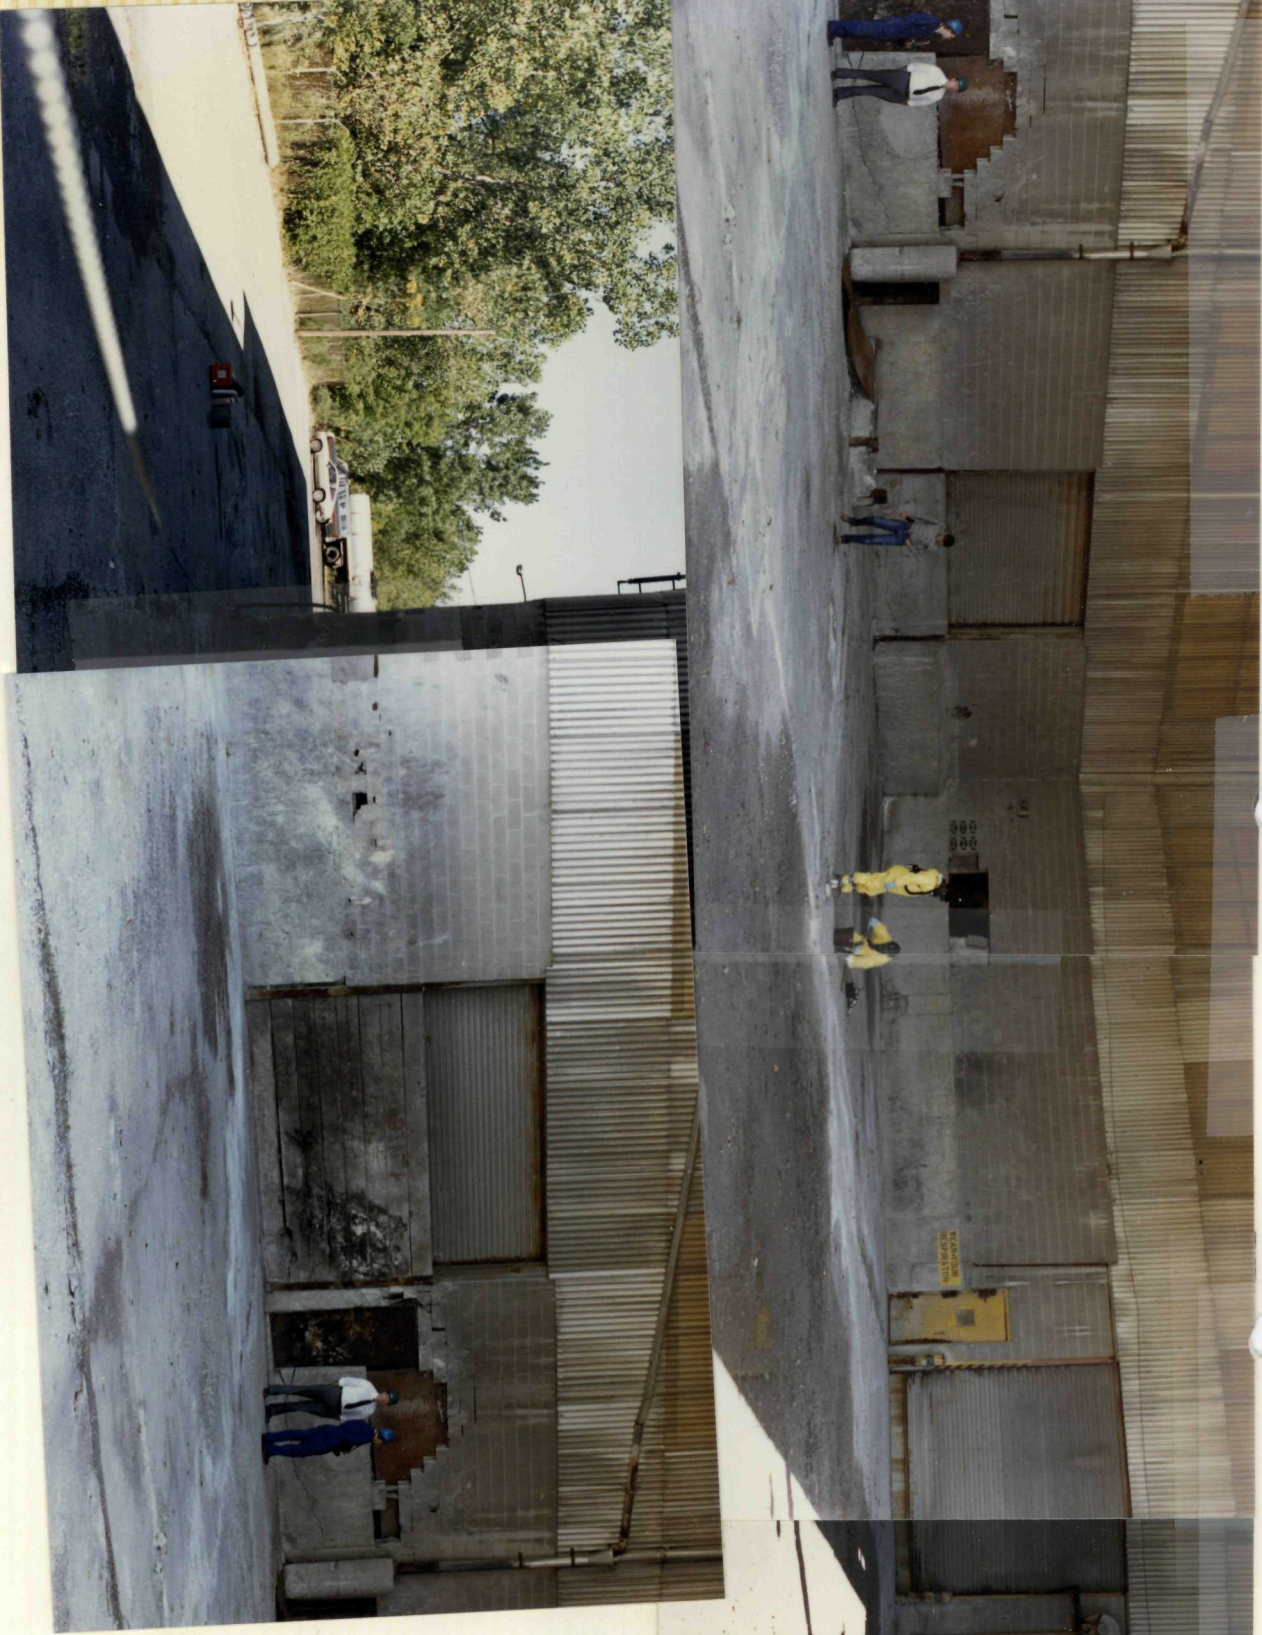
- o The concrete pad used for storing lead contaminated material measured approximately 85 feet x 75 feet and was covered by a roof. Walls protected the area on the north and east sides, but no walls were present on the south and west sides (Photograph 1). The concrete on the storage pad was cracked. Dust was also found on the storage pad.

PANORAMA 1:
 TARACORP,
 McCook, IL.
 Concrete pad
 composite
 sample area.
 Driveway in
 the lower
 left photo
 heads north
 out of the
 site. The
 loading bays
 in the upper
 right photo
 lead due
 east towards
 the furnaces.
 (Photo by
 Scoville,
 1030-1230,
 8/28/86.) *msd*

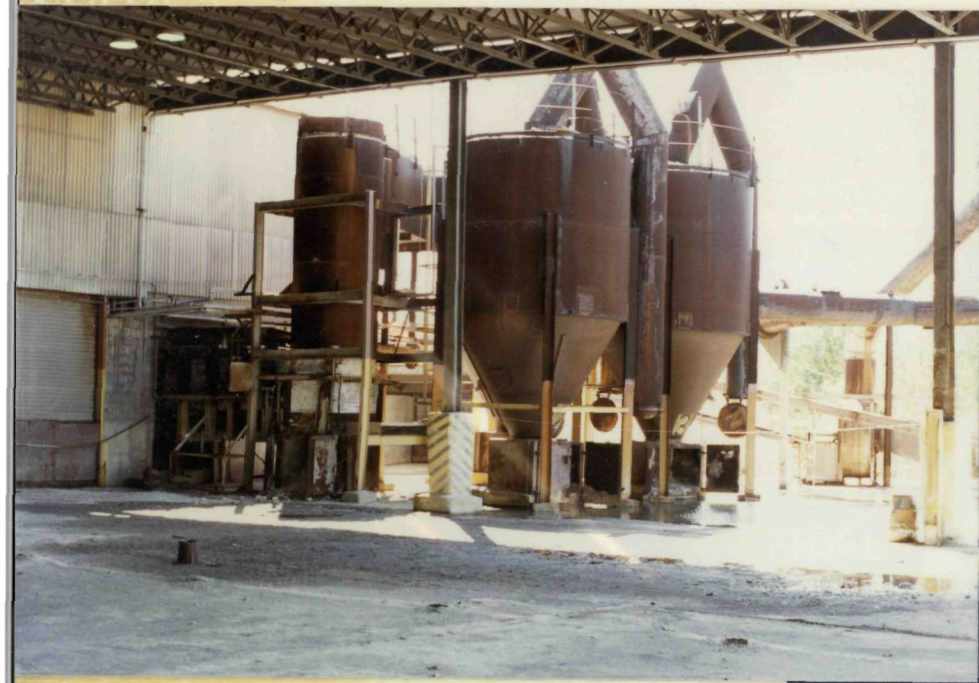
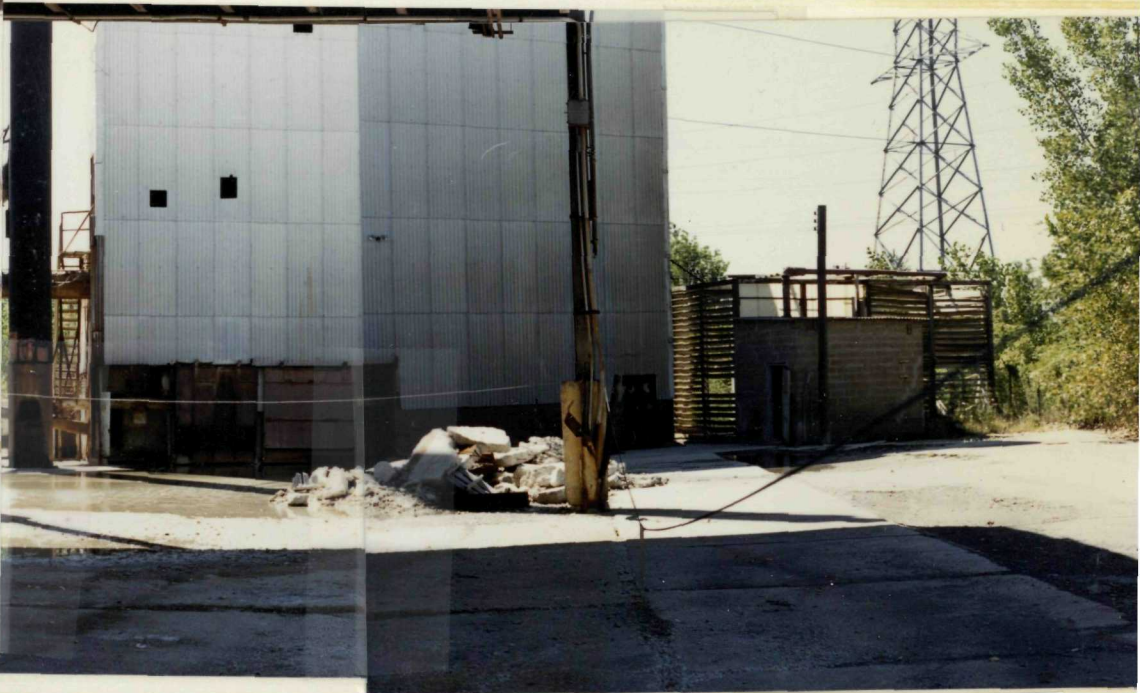
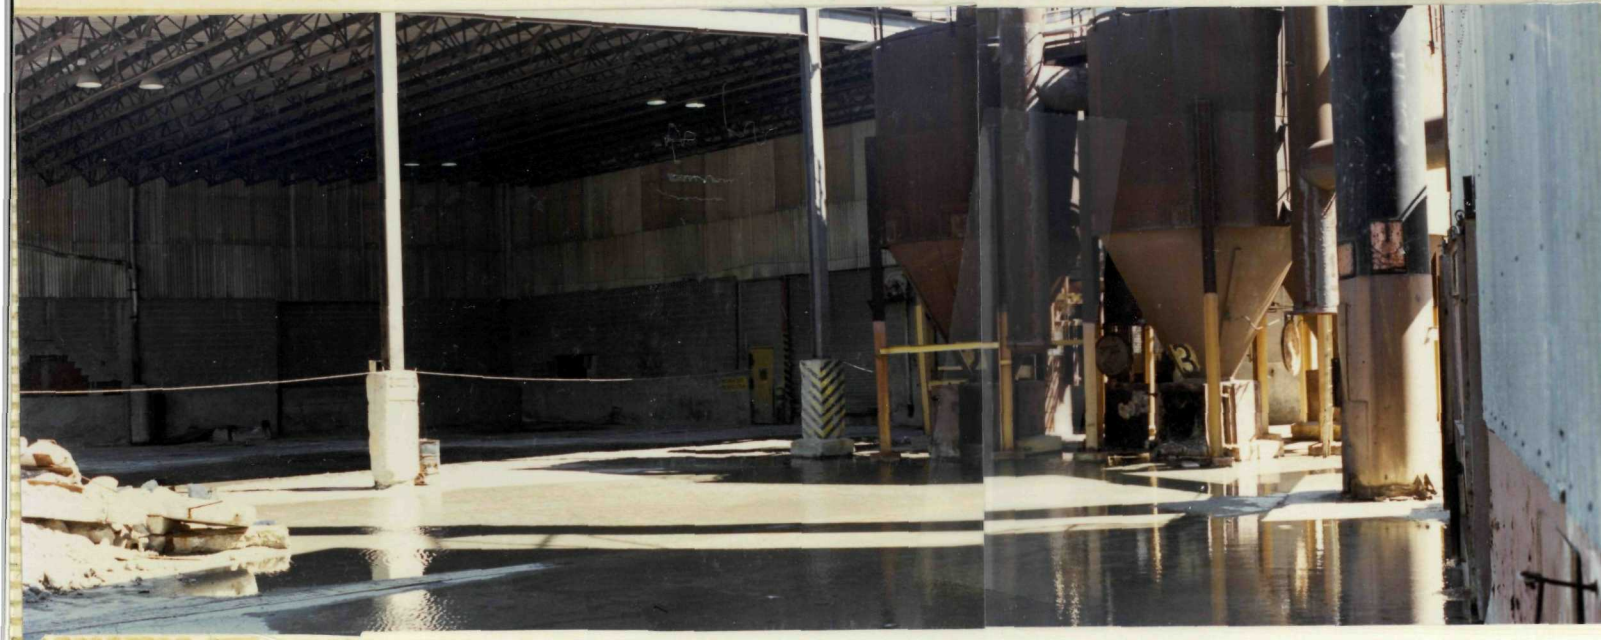
- o A storm sewer drain near the storage pad was plugged and standing water was observed along the storm grate leading to the storm sewer.
- o Broken pieces of battery casings were found on the ground on the east side of the site (Photograph 10).
- o A drainage ditch flowed within a few feet of the south perimeter of the facility (Photograph 7).
- o No defined drainage patterns were detected leaving the site, but the property sloped towards the south and east, which was also the direction of the drainage ditch.
- o Vegetation in the ditches along the site borders did not exhibit signs of stress (Photograph 7).

PANORAMA 2:
TARACORP, McCook,
IL.
Samples were
collected of the
water in the puddle
in the lower series
of photos and the
water in the cooling
tower in the upper
right photo. A
clogged drainage
grate leads out of
the puddle in the
lower left photo.
(Photo by Scoville,
1030-1230, 8/28/86.)

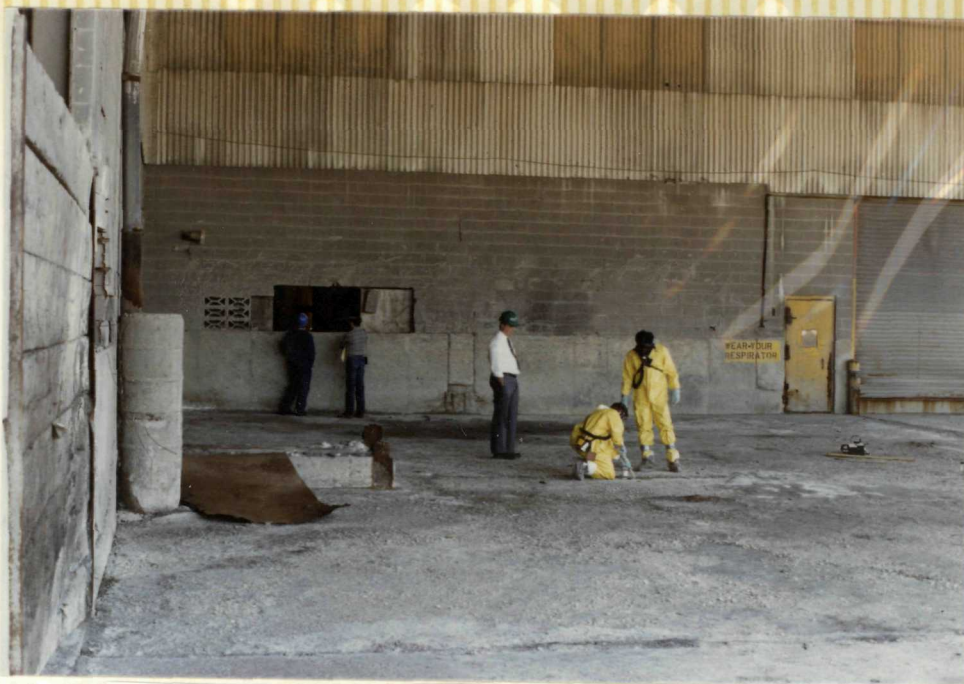
PHOTOGRAPH 3: TARACORP, McCook, IL.
TAT members Lorenz and Babusukumar prepare a composite sample of the concrete pad shown in Panorama 1. Mr. Ron Stoker of Moreco Energy, Inc., observes as George Webb of Taracorp and Walter Francis from the U.S. EPA peer into the interior of the building. Note the sign on the wall advising the use of respirators.
(Photo by Scoville, 1030-1230, 8/28/86.) *ZAS*

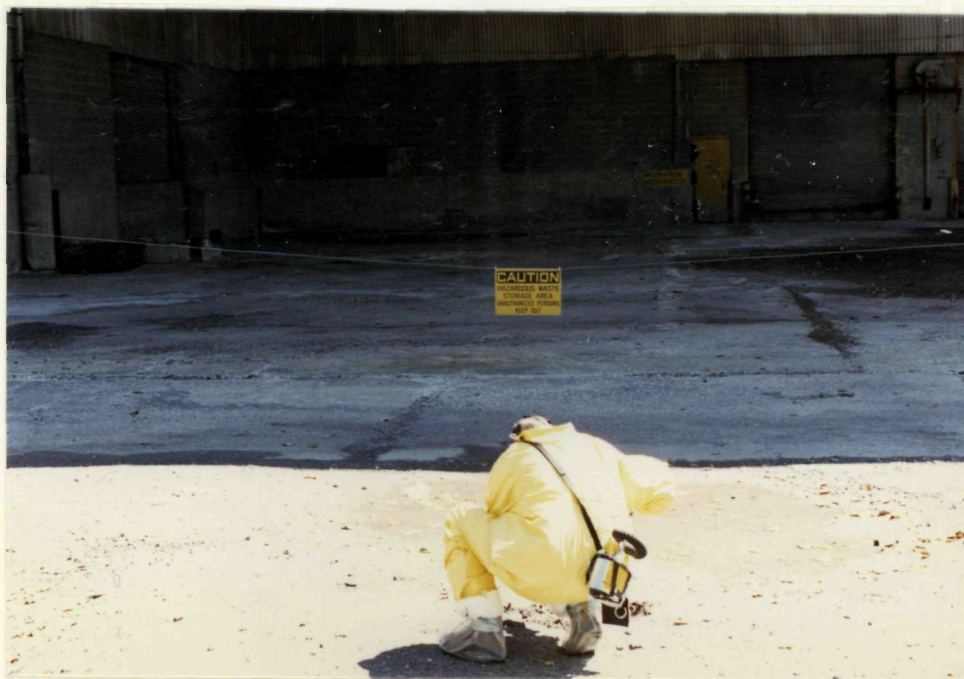
The soil sample (S05) from the traffic way had a lead concentration of 27.8% and arsenic concentration of 1,890 ppm. There exists the potential for migration of contaminants off site from vehicular traffic.

PHOTOGRAPH 4: TARACORP, McCook, IL.
TAT member Lorenz samples a high traffic area west of the concrete pad on the driveway. Caution sign indicates that the area is restricted due to the storage of hazardous wastes.
(Photo by Scoville, 1030-1230, 8/28/86.) *ZAS*

- o Vehicular traffic be curtailed or vehicles be decontaminated before exiting the site;

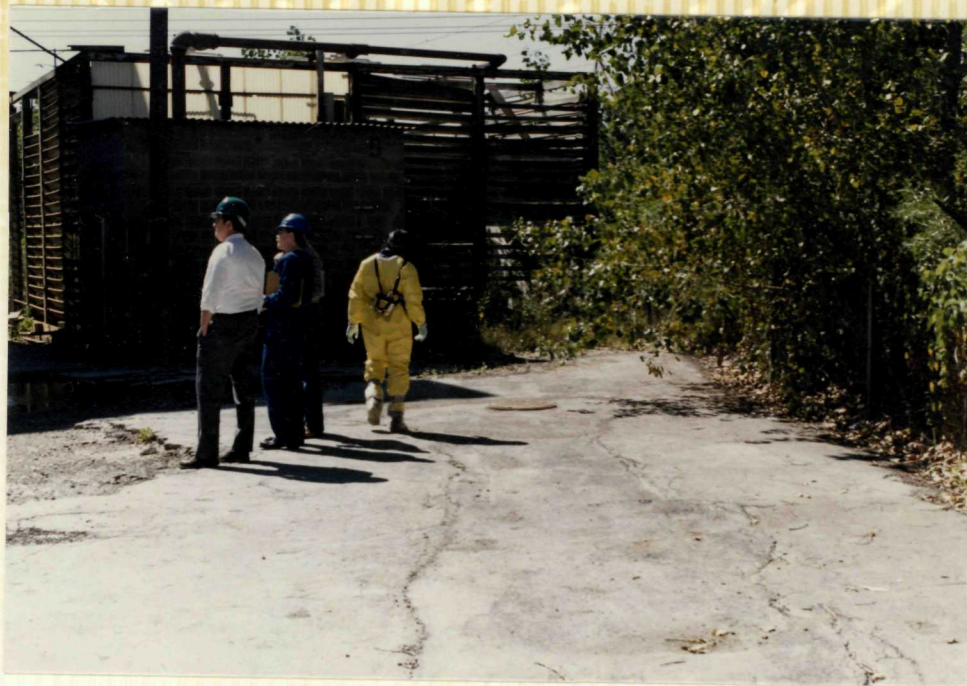
PHOTOGRAPH 5: TARACORP, McCook, IL.
TAT member Babusukumar walks southwest towards a manhole cover near the cooling tower. A soil sample was collected in the southwest corner of the Taracorp property near a drainage ditch.
(Photo by Scoville, 1030-1230, 8/28/86.) *MS*

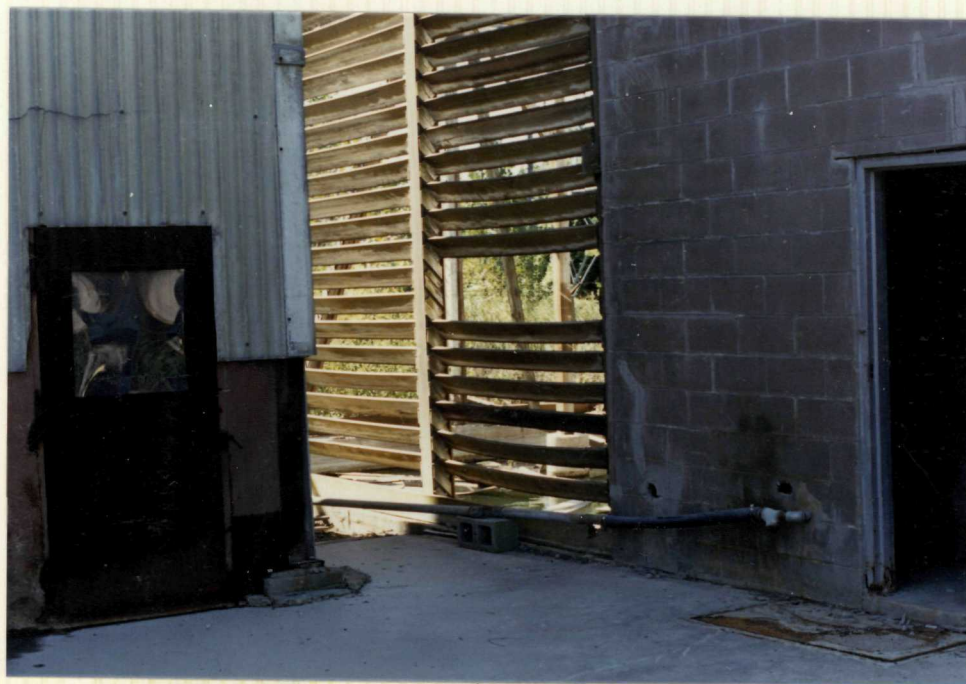
PHOTOGRAPH 6: TARACORP, McCook, IL.
Most of the cooling tower had been demolished. The water in the area on the other side of the wood panels was approximately 3 feet deep. East of the cooling tower was the bag room, which is shown on the left side of the photo.
(Photo by Scoville, 1030-1230, 8/28/86.) *MS*

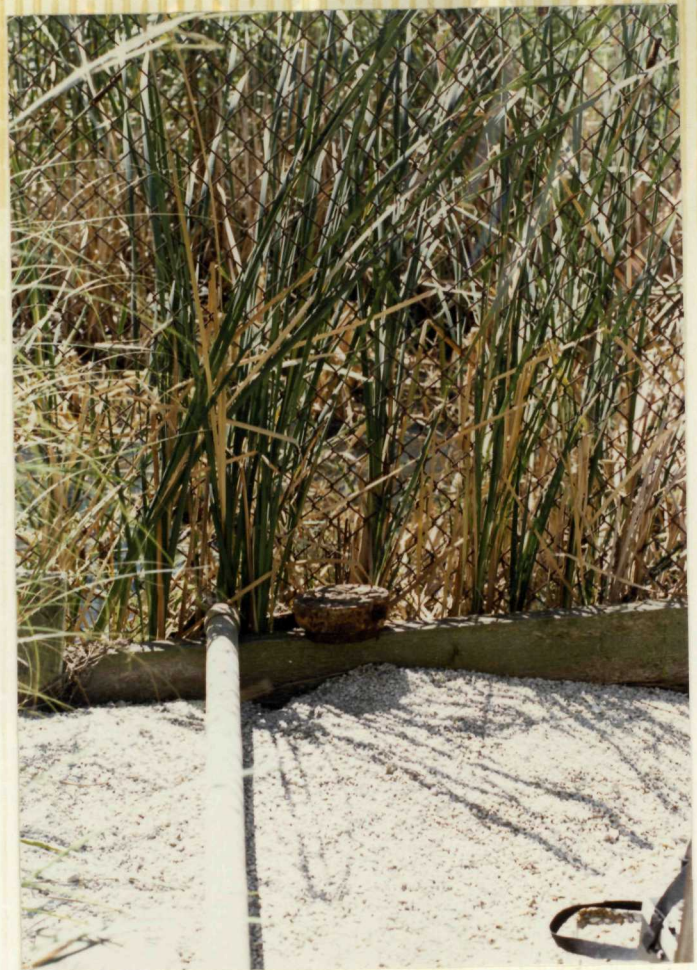
PHOTOGRAPH 7: TARACORP, McCook, IL.
The tall vegetation in the ditches
that drained the property did not
show any indications of being
stressed. The pipe shown in this
photo was not connected. A water
line for fire hydrants was buried
on the other side of the fence.
(Photo by Scoville, 1030-1230,
8/28/86.) *ZMS*

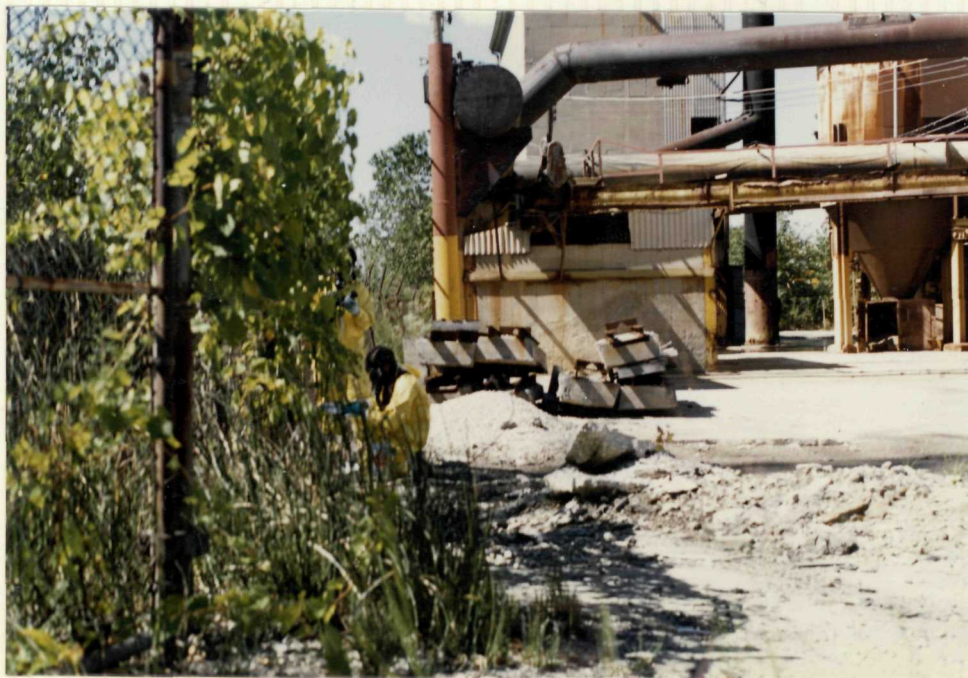
PHOTOGRAPH 8: TARACORP, McCook, IL.
TAT member Lorenz samples an area east of the bag
room and cyclones along the south border of the
property.
(Photo by Scoville, 1030-1230, 8/28/86.) *ZMS*

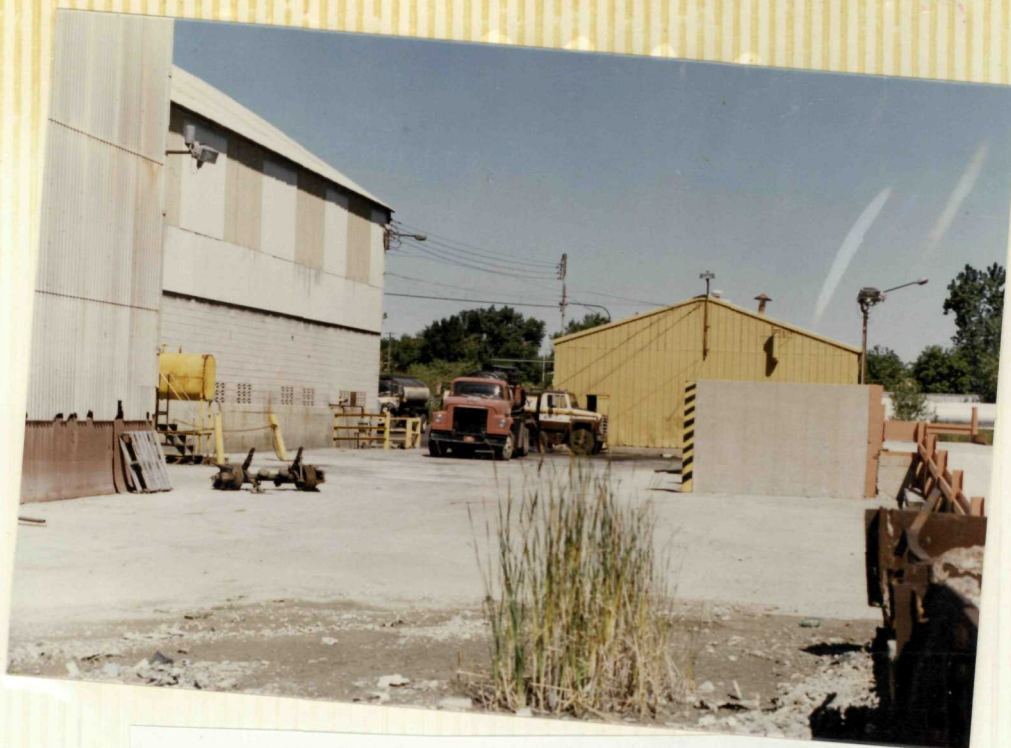
PHOTOGRAPH 9: TARACORP, McCook, IL.

A Moreco Energy truck entered the property as the TAT was sampling. Moreco rented the property from Taracorp for use as a maintenance yard. A train siding entered the property to the right (east) of the ramp. Parts of battery casings and battery posts were found scattered in this area as well as near the cooling towers.

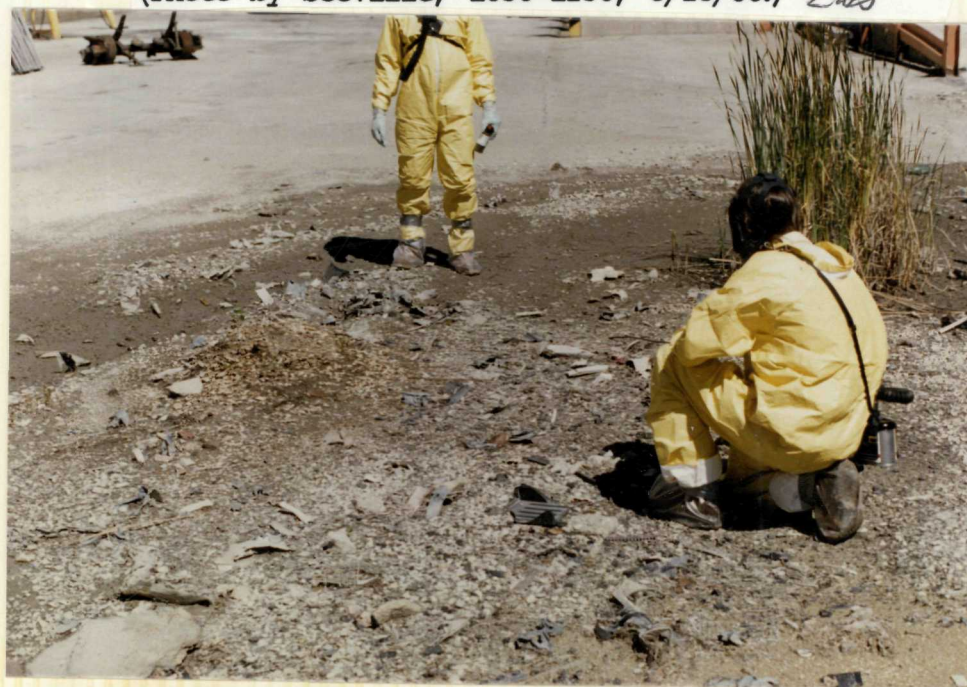
PHOTOGRAPH 10: TARACORP, McCook, IL.

limit for typical soils. The sample from the area of broken battery casings near the railroad spur (S08) contained the highest lead level at the site (68%).

TAT member Lorenz samples the soil where battery parts were found. The TAT estimated that 20 to 40 cubic yards of battery debris lined the railroad siding.
